REPORT OF AIRCRAFT ACCIDENT

(1) Place Provisional Army Air Base #2 APO 247 (2) Date 10 February 1945 (3) Time 0745
AIRCRAFT: (4) Type and model B-29 (5) No. 42-65255 (6) Station Provisional AAB #2
Organisation: (7) 20AF, XXI B.C. (8) 505th Bomb Gr. (9) 43rd Bomb Sqdn.
(Command and Air Force) (Group) (Squadron)

PROCEEDINGS OF AIRCRAFT INVESTIGATION BOARD
FOR ACCIDENTS

The Board convened on 12 February 1945 at Provisional Army Air Base #2, APO #247, pursuant to Special Order No. 14, paragraph 2, as amended by Special Order No. 25, paragraph 4, this headquarters, for the purpose of examining witnesses and determining cause of the aircraft accident involving B-29 airplane #42-65255.

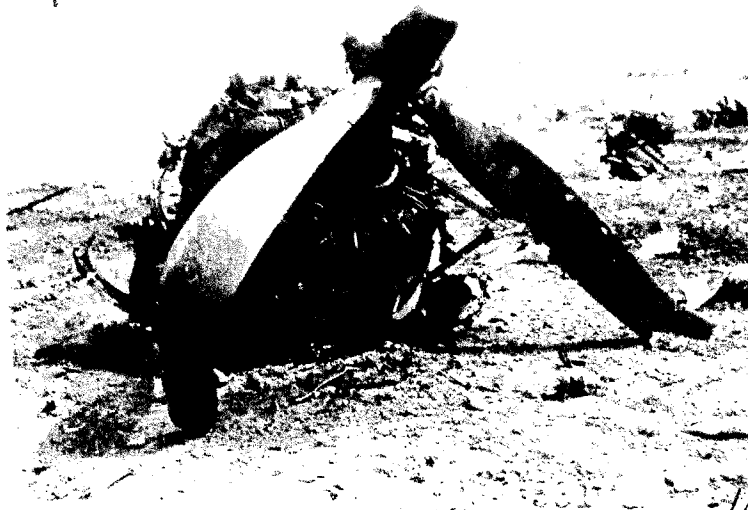
(53) Cause of accident Undetermined. Exploded. No evidence of any type available to determine primary cause of accident.

Aircraft was loaded with eight (8) 500 lb G.P. bombs and two (2) 500 lb incendiary bombs. On take-off the airplane acted normally to all witnesses until approximately two-thirds of the way down the 8500 ft runway. At this point although nearly airborne the power was reduced and one application of the brakes was made. Flaps were dropped to the full down position and the nose wheel lifted clear off the ground as though in an attempt to increase the drag. This action at such high speed caused the lift to momentarily increase resulting in the left main wheels losing contact with the ground for a short distance. About 1200 ft from the end of the runway the brakes were again applied and apparently kept on. The airplane was slowed down to an estimated 40 MPH by the time the end of the runway was reached. No attempt was made to turn onto the taxiway, which could have been accomplished successfully. The airplane ran off the end of the runway and down a slope (this down grade estimated at 2%). A mound of dirt and coral approximately ten feet high and seventy feet long was hit. As the aircraft went up this mound it broke in two, fell on the far side and immediately exploded. There were no survivors. One bystander, approximately five to seven hundred feet away was killed by flying debris. The aircraft was so completely demolished that investigation to determine any reason why the Airplane Commander decided to stop his take-off roll was impossible. No reason can be afforded for failure of the airplane commander to turn the airplane onto the taxiway at the end of the runway.
